ANALYSIS OF THE INFLUENCE OF LOOSE TERMINATION LEVEL WITH INCREASING TERMINATION TEMPERATURE OF ELECTRICAL EQUIPMENT USING INFRARED THERMOGRAPHY

Pranoto Budi Laksono^{1*}

¹Department of Electrical Engineering, Universitas Pamulang, Indonesia

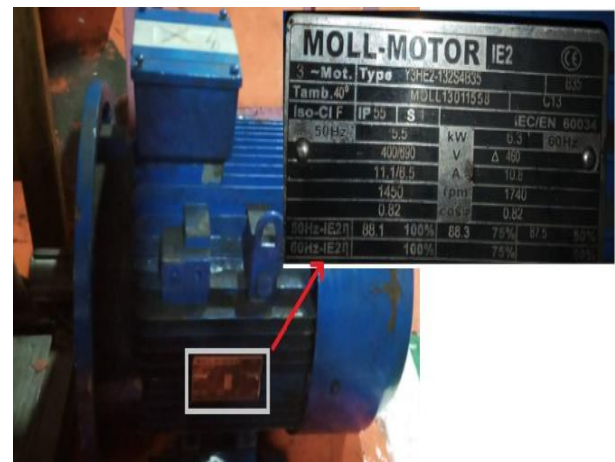
For the load section in the form of a 3 phase induction motor 5.5 KW, 11.1 Ampere, 380 V, 1450 rpm and for standard torque (τ) the tightness of the U, V, W terminals is 1.5 Nm as shown in Fig.4. The measuring instrument used is the IR thermograph type Ti50 series, Irtek brand. Terminal torque setting using a torque screwdriver "Toptul" which can be set the torque value (Fig.5).

Figure 4. Induction Motor 5,5 KW

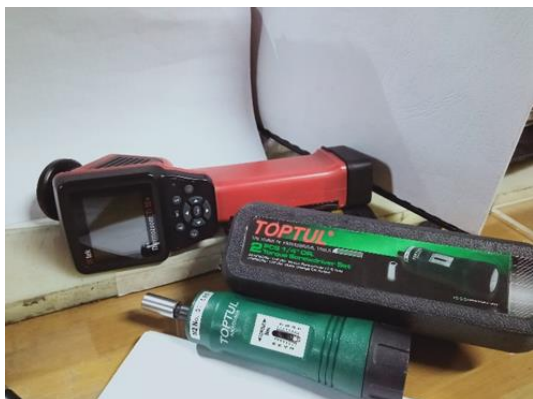
Figure 5. IR Thermograph and Variable Torque Wrench

The testing methodology is that the motor is connected to a VSD (Variable Speed Drive) where terminals V and W are set to a torque of 1.5 Nm (according to standard) while terminal U is set to 3 conditions, namely $\tau_1 = 0,5$ Nm (67% below standard), $\tau_2 = 1$ Nm (33% below standard), and $\tau_3 = 1,5$ Nm (same with standard). Each different torque setting condition was tested with 3 different motor speeds, namely 20Hz, 40Hz, and 50Hz. For each setting condition, the temperature data is taken starting at 0 hour, 2nd hour, 4th hour, 6th hour and finally 8th hour.

Terminal temperature data retrieval is carried out with an IR thermography and validated using a multi-tester with a thermocouple base.

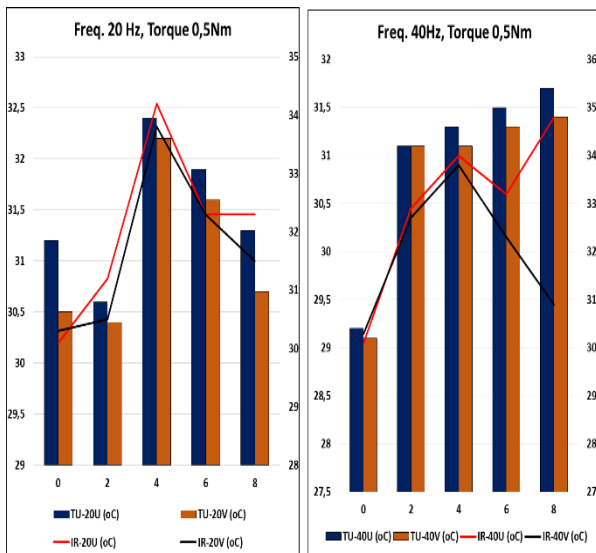
Figure 6. Graph of Temperature Measurement Data for terminals U ($\tau_1 = 0.5$ Nm) and V($\tau_3 = 1.5$ Nm) with frequency setting 20Hz (left) and 40Hz (right)

From Table 3 to Table 5 and the graphs in Fig.6 and Fig.7 (left) can be explained as follows, when terminal U is set to a torque of 0.5 Nm and terminal V, W is set to a torque of 1.5 Nm and the motor is tested to rotate with a frequency of 20 Hz, at 0 o'clock (about 10 minutes from the moment it is turned on) the temperature of terminal U (IR-20U) is 30.1 °C while the temperature of terminal V (IR-20V) is

30.3 °C, meaning that the initial temperature of each terminals like that. When the motor has been running for about 2 hours, a second measurement is made, the IR-20U is 31.2°C and the IR-20V is 30.5 °C, and so on until the 8th hour (meaning 8 hours from the start of operation). It can be seen that the temperature increase at terminal U tends to be higher (temperature increase of 13.6%) compared to terminal V (11.6%) during the 8-hour test process. The graph is shown with a red line for terminal U and a black line for terminal V. For the blue and brown bar graphs are comparative data taken using another temperature measuring instrument (multitester with thermocouple sensor). It can be seen that the trend is similar to the results of measurements using an infrared thermograph. The same thing is also seen for the frequency settings of 40Hz (15.6% compared to 11.6%) and 50 Hz (13.4% compared to 7%) with a torque treatment of 0.5 Nm at terminal U, and 1.5 Nm to terminal V and W. These measurement conditions done with a torque setting of 67% below standard.

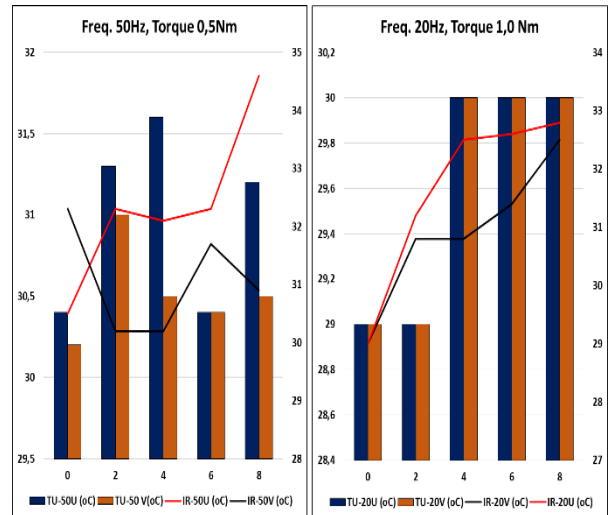
Figure 7. Graph of Temperature Measurement Data for (left) \rightarrow terminals U ($\tau_1 = 0.5Nm$) and V($\tau_3 = 1.5$ Nm) with frequency setting 50Hz, (right) \rightarrow $\tau_1 = 1$ Nm and 40Hz

Tables 6 to Table 8 and the graphs in Fig.7 (right) and Fig.8 present measurement data with the condition for the U terminal the bolt torque is set to 1 Nm or 33% below the standard value, while the V and W terminals are still the same, namely 1.5 Nm (100% according to standard torque). The frequency setting treatment is still the same, namely three conditions, 20Hz, 40Hz, and 50Hz. The trend condition is similar to the trend in the previous graph in Fig.6 and Fig.7 (left), namely terminals U and V during the testing process experienced an increase in temperature, but for terminal U tended to be higher than terminal V (13.1% compared to 12.1%, 13.8% compared to 12.3% and 12.3% compared to 7.8%). For data that is empty in the 40 Hz frequency column, namely at 6 and 8 hours, this is because there are technical problems where the infrared thermograph battery is low and needs to be recharged for a long time, so no data is measured with the infrared thermograph. For conditions, each frequency setting shows a trend similar to the previous data.

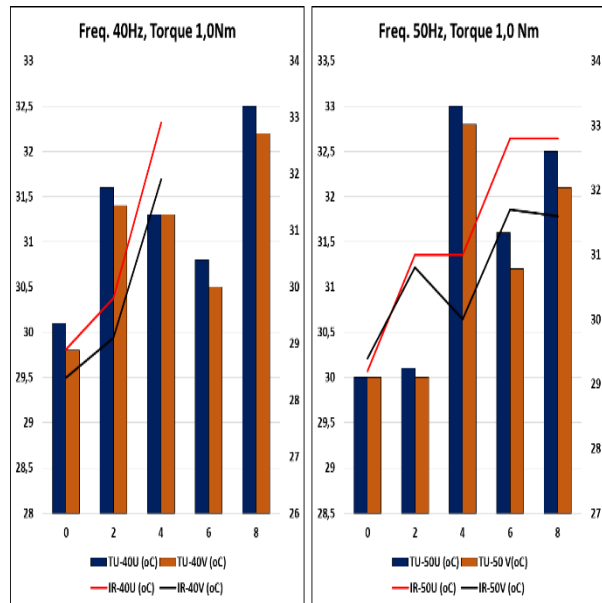
Figure 8. Graph of Temperature Measurement Data for terminals U ($\tau_1 = 1$ Nm) and V($\tau_3 = 1.5$ Nm) with frequency setting 40Hz (left) and 50Hz (right)

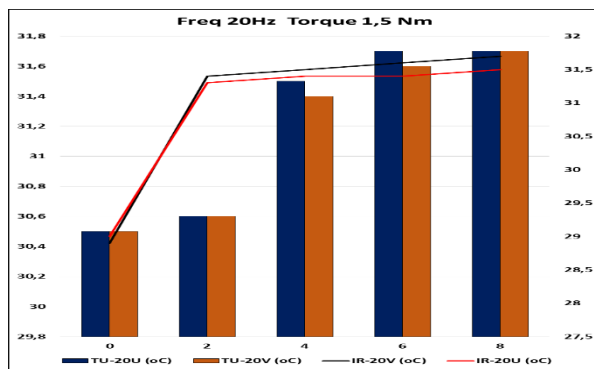
Figure 9. Graph of Temperature Measurement Data for terminals U=V ($\tau_1= \tau_3 = 1,5$ Nm) with frequency setting 20Hz

Table 9 and the graph in Fig.9 present measurement data for the standard condition of the motor terminal torque of 1.5 Nm. It looks similar to the data in Tables 3 to 5 and Tables 6 to Table 8 that the increase in the duration of operating hours causes an increase in terminal temperature. However, when viewed from the trend from 0 to 8 hours, the temperature increase is almost similar between terminal U and terminal V, although there is still a small difference in value between the two, which is about 8.6% compared to 9.7%

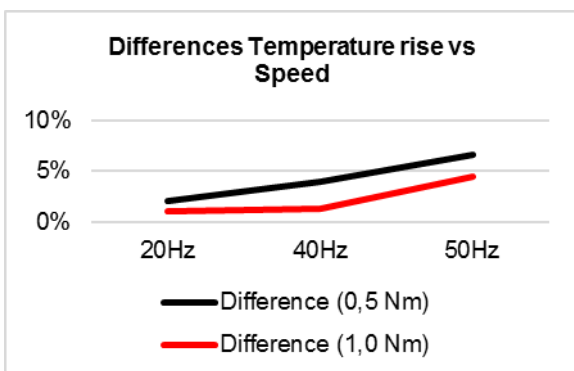
Figure 10. Differences Temperature rise vs Speed

Table 10 and the graph in Fig.10 shows that the increase in temperature is directly proportional to the level of slack termination is also directly proportional to the increase in motor speed. If the termination torque level is lower and the motor speed is increasing, the terminal temperature rise will be drastically higher.
